Alpine Surveys

Damp Investigation Survey Final Report

An Address, Buckingham, Bucks

06 March 2017

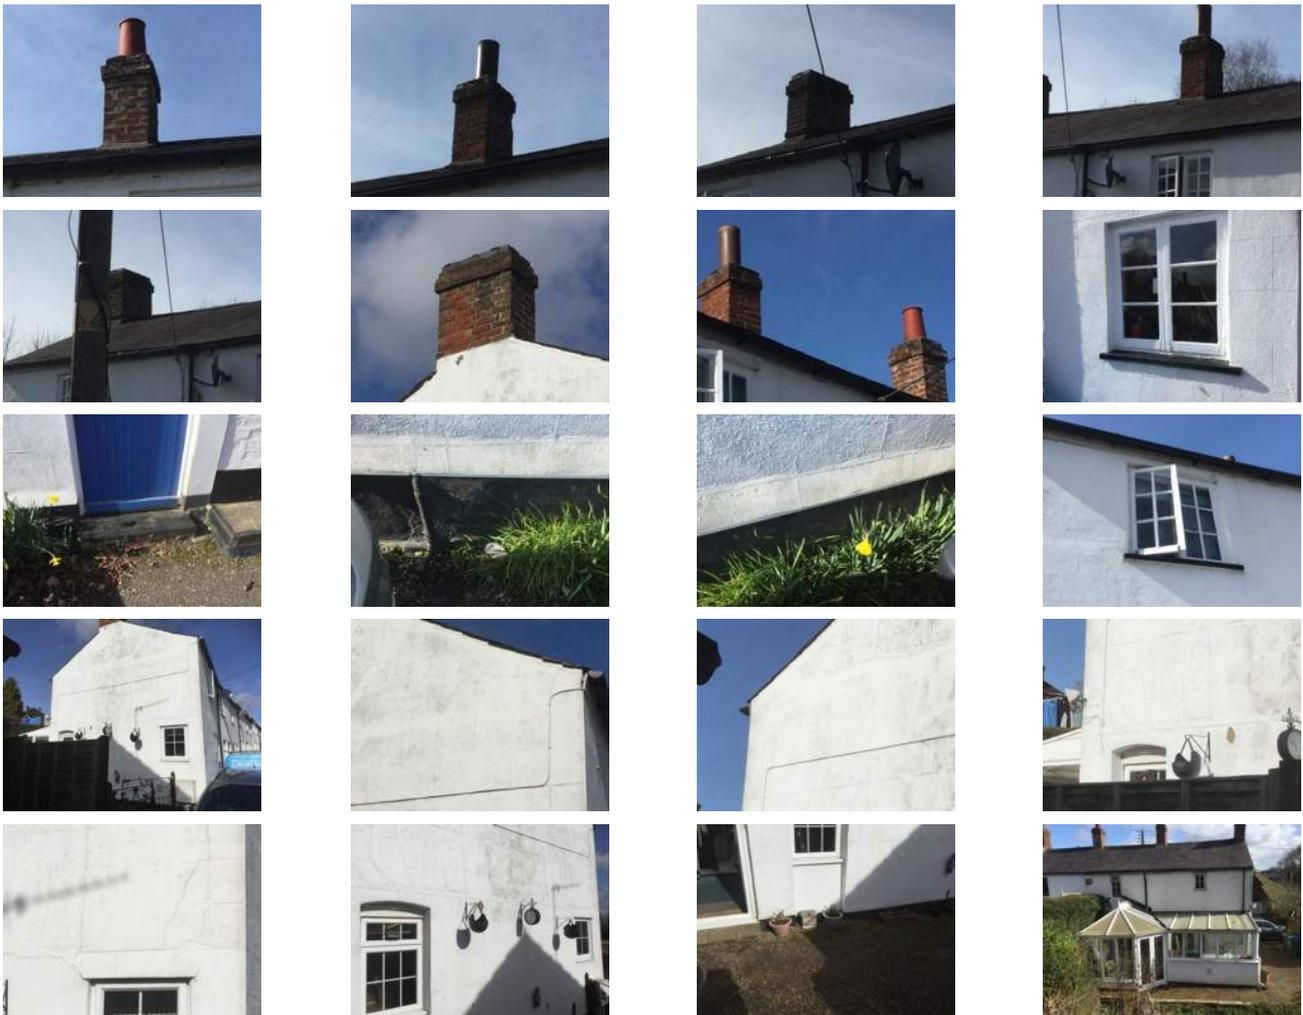
Initially we assessed the exterior of the property, and found that the pointing, brickwork and flaunching were deteriorated on the chimney stacks, which includes the stack on the party line. We noted that there was movement in the stacks, and that there was vegetation growing out of the flaunching on the crown. This level of deterioration will increase the risk of moisture penetration into the stacks, and thereafter down into the property beneath. The structure is solid brick construction, and it has been rendered and painted, with numerous coats of paint. The paint was found to be blown in numerous places, indicating that it is non-breathable. Being of solid construction, there is a requirement for the wall to breathe, in order to remain at an acceptable moisture content level. On the gable end, we found that the render was cracked across the elevation, which is the result of trapped moisture, and possibly the movement of the stack. To the rear we found that the fascia boards were deteriorated, which is normally an indication of unmaintained guttering, which has filled with silt and debris, and caused over spillage. We found that some of the windows have been replaced with UPVC, however some were still wooden and were rotten. We also found that the front door was deteriorated towards the base. This level of deterioration will increase the risk of moisture penetration through the timber, and into the adjacent structure.

1. We recommend that the pointing on the chimney stacks is raked out, and repointed using a cement based mortar. At this time the flashing should be replaced using a cement based mortar. Any bricks found to be cracked, damaged, eroded by 10% or more, porous or blown due to moisture absorption, should be replaced.

5. The deteriorated facias to the rear should either be replaced, or repaired, prepared, and painted. The deteriorated wooden windows, sills and front door frame should either be replaced, or repaired, prepared and painted using an external protective paint.

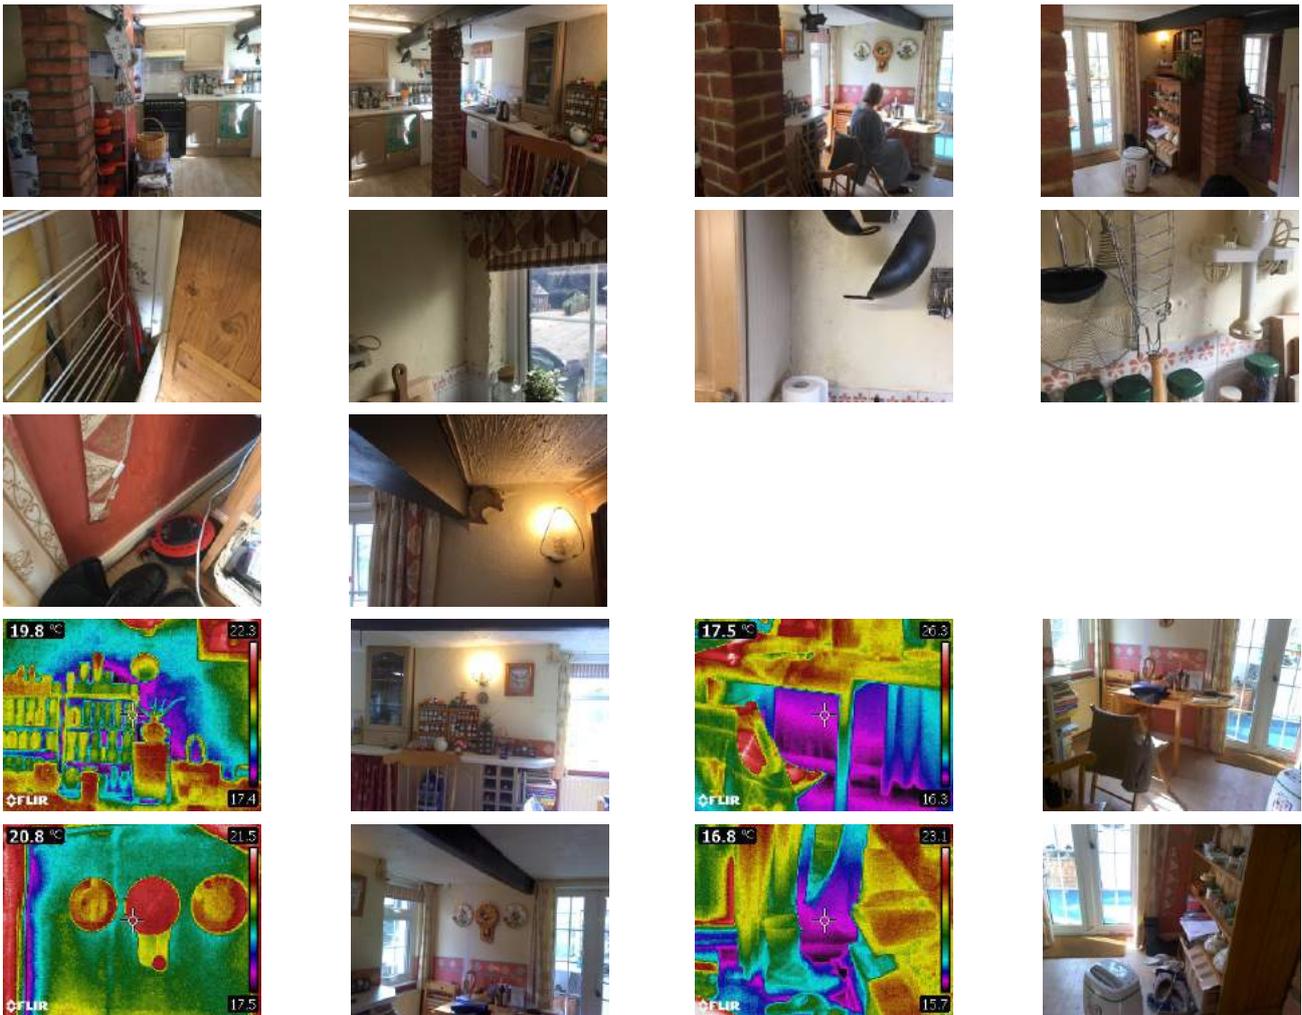
Kitchen Diner

Within the kitchen diner we found that there were visible signs of deterioration, which is due to moisture penetration and the high ground levels. The RD levels across the rear facing wall were between 167 and 213 at high level, and between 183 and 999 at low level. This is the result of moisture penetration and trapped moisture. Across the side external wall the RD levels were between 208 at high level, and 281 at low level to the right of the chimney stack. Across the chimney breast the RD levels were between 191 and 999 at high level, and 999 at low level. This is the result of moisture penetration into the stack above, and a result of moisture penetration through the side elevation which has become trapped. The side external wall to the left of the stack has been dry lined. We believe that this has been undertaken in order to cover the damp issue. This will stop the internal breathing process, and again trap moisture in the wall. The MC levels obtained were between 16 and 19%. This confirms that the wall behind is damp. We found that the recess of the left window has been poorly plastered, and the RD levels were all 999. This is the result of moisture penetration and trapped moisture. Across the front facing wall the RD levels were all 999. We noted that the plaster was deteriorated and blown. We also noted that the plaster appeared to be a gypsum type plaster, as opposed to a breathable Lime based plaster.

6. The ground levels should be lowered in order to create the recommended drop of 150mm from internal floor level, down to external ground level.
7. Any dry lining internally on external walls should be removed, and the walls plaster with lime plaster.

8. Any defective internal plaster should be replastered using a breathable lime based plaster. Ideally all of the gypsum type plaster on the external walls should be removed, and the walls plaster with a lime plaster.

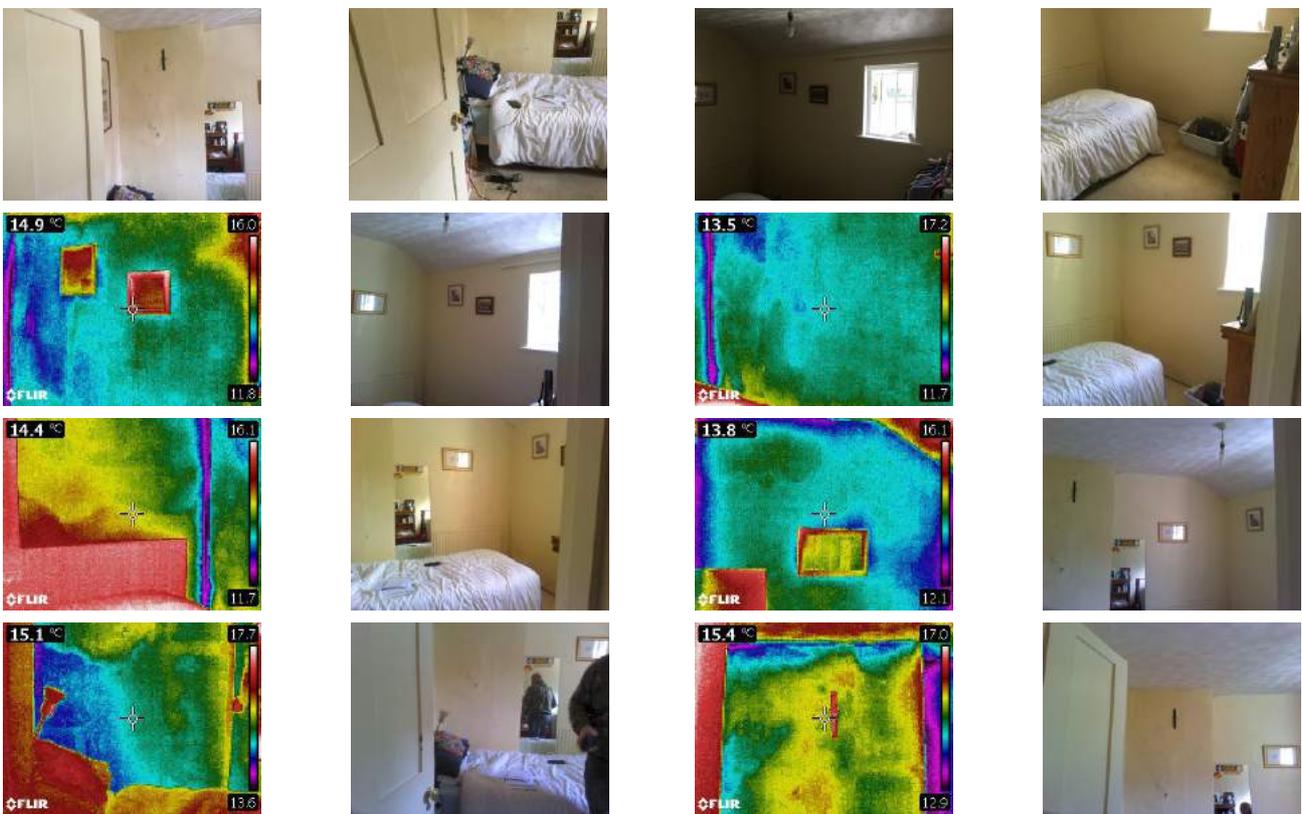
Third Bedroom

Within the third bedroom we found that the chimney breast was very deteriorated, as was the ceiling adjacent to the external side elevation. The plaster was deteriorated and blown across the rear facing wall at low level adjacent to the side external wall. The RD levels across the rear facing wall were between 167 and 212 at high level, and increasing to 999 at low level. Across the chimney breast the RD levels were 999 throughout. This is the result of moisture penetration into the deteriorated stack above. Across the alcove the RD levels were again 999 throughout. This is the result of moisture penetration through the side elevation, and spread from the chimney stack. The RD levels across the stud partition party wall to the second bedroom were acceptable. Across the bathroom partition wall the RD levels were acceptable.
