Damp Investigation Survey Final Report

Another Address, Another Street, Another Town

02 March 2016

Alpine Water Management Ltd

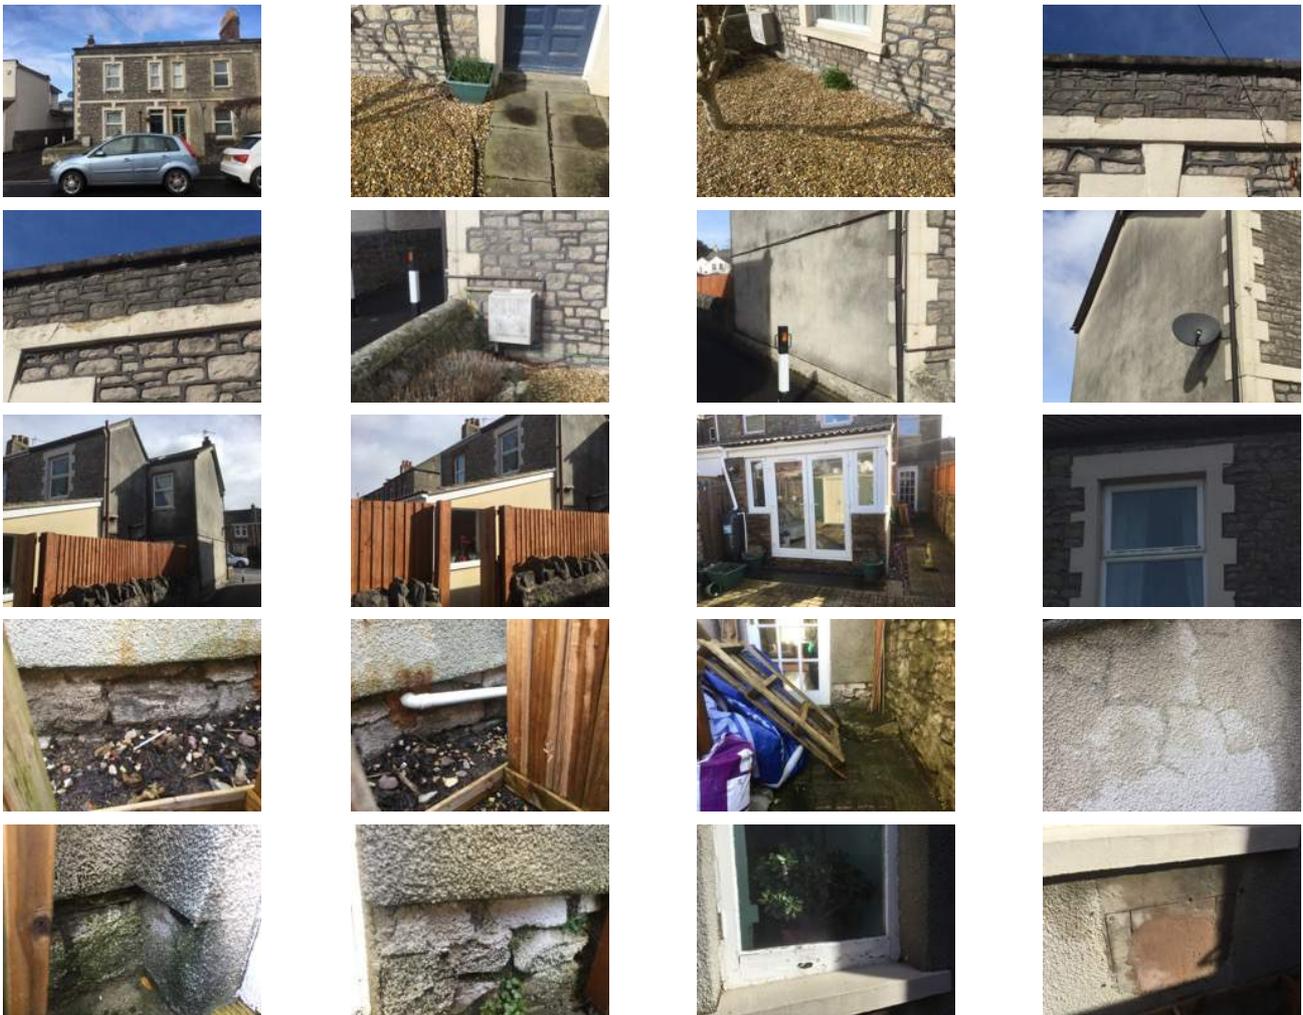
Exterior Details

Initially we assessed the exterior of the property, and found that the painted rendered stone was deteriorated to the front, and damaged. The pointing and stone appeared porous, and we believe will absorb moisture. The the front and rear, the stone boundary walls are built up to the property elevations, and therefore any absorbed moisture will penetrate the front and rear elevations. To the side and rear there has been a render cladding, which is cracked in numerous places, and is allowing moisture to penetrate. We believe that the cladding is a cement based material, which is non breathable. Non breathable materials will trap moisture within the elevations. The wooden window to the rear is deteriorated, which will allow moisture to penetrate into the wall beneath. To the front and rear we found that the ground level was high, and was at internal floor level. To the side of the property the Tarmac drive has been raised, and appears to be above internal floor level. The recommendation is a drop of 150mm from the internal floor level down to external ground level. Therefore the risk of moisture penetration into the base of the wall and internal floor structure is much increased by the raised levels.

2. We recommend that the deteriorated render cladding is removed with care, so not to cause unnecessary damage to the structure beneath.
 3. We recommend that the deteriorated pointing is raked out, and repointed using a breathable lime based mortar. Any bricks/stone found to be cracked, damaged, eroded by 10% or more, porous or blown due to moisture absorption, should be replaced. At this time the deteriorated stone to the front at first floor level should be corrected.

4. We recommend that thereafter the elevations are rendered using a breathable lime based render, and for decor a lime wash should be used.
 5. The boundary walls should have an air break installed between the elevation and the boundary, in order to stop further moisture penetration.

6. The ground levels should be lowered in order to create a 150mm drop from internal floor level down to external ground level.
 7. The deteriorated window frame should be replaced or repaired and decorated to stop moisture penetration.

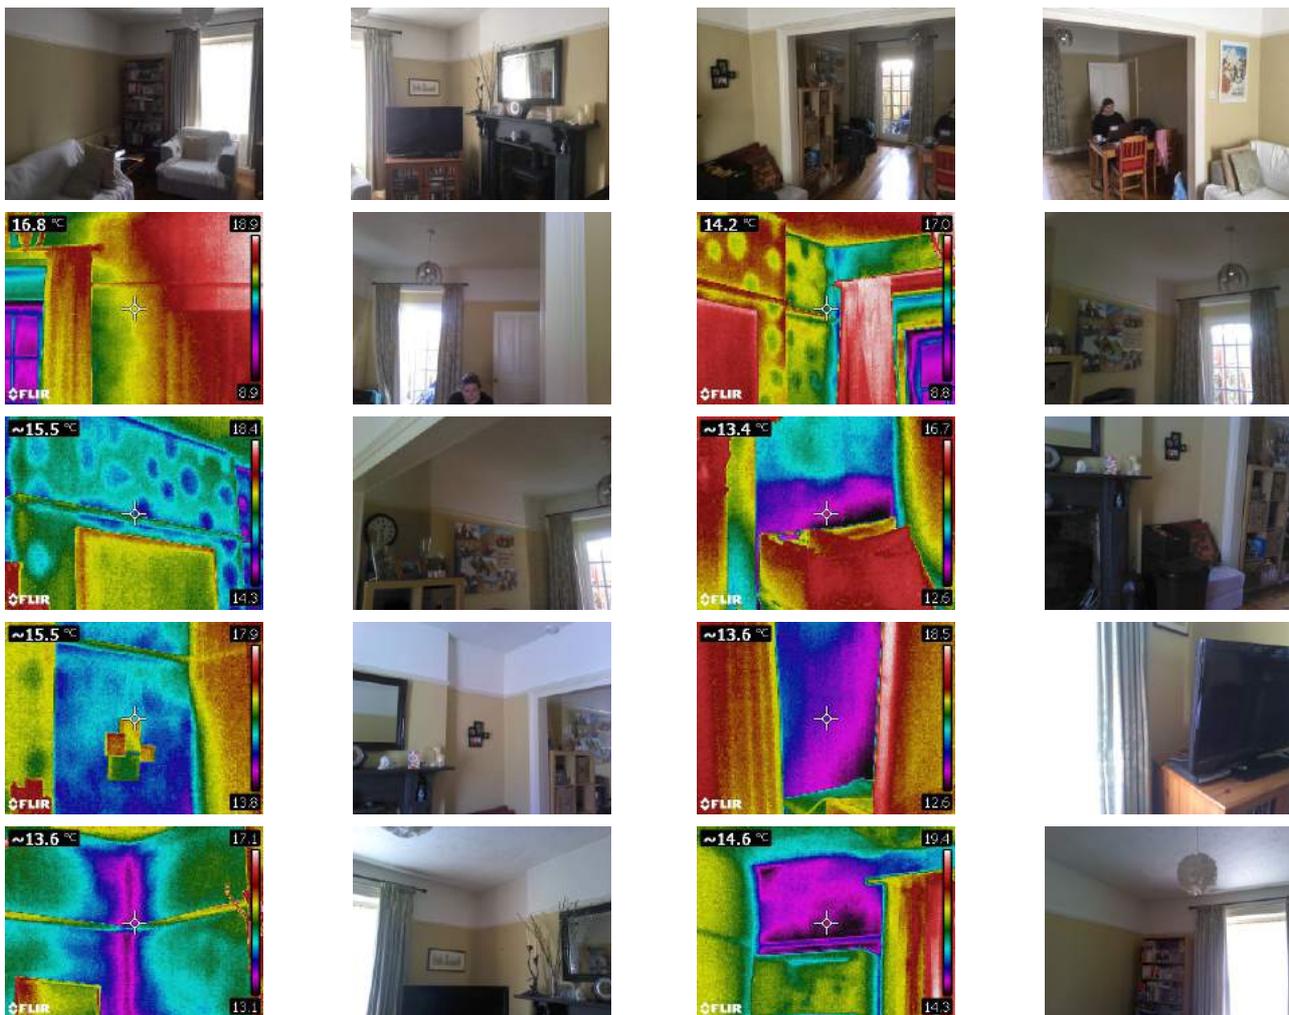
Lounge Diner

Within the lounge diner we found that the RD levels across the front facing wall were between 197 at high level, and 486 at skirting level. The plaster on the front wall has blown in places as a result of moisture within th wall. Across the side external wall within the lounge the RD levels were between 211 at high level, and 999 at skirting level. Across the chimney breast which has been dry lined the RD levels were between 177 and 289. This indicates that the chimney breast is damp behind the lining. Within the dining area the RD levels in the left alcove were 167 at high level. Across the chimney breast the RD levels were generally 999. Within the right alcove the paper is peeling, and the plaster is blown due to RD levels of 999, and MC levels up to 100%. Across the rear facing wall the RD levels were between 239 a high level, and 384 at skirting level. The RD levels on the internal party wall were high adjacent to the front and rear elevations, but reduced into the room. The moisture levels obtained are a result of moisture penetration through the front stone and pointing, and through the render cladding. The cladding is thereafter trapping moisture within the walls. The RD levels on the floor to the front of the property were acceptable, however to the rear they increased to 211, indicating that moisture is penetrating the floor structure as as result of the saturated wall base, and the high ground level.

8. Any Gypsum type plaster, or deteriorated plaster should be removed internally from external walls, as should any dry lining. The walls should then receive breathable lime based plaster.
